# Cows and Fish

## Riparian Health Summary Report 2021

Sarah Rice, Town of Bonnyville  
Jessie Lake

<b>Waterbody:</b>	Jessie Lake	<b>Location:</b>	NE 12-61-6 W4M
<b>East End Waypoint:</b>	515759 E, 6012638 N 12U	<b>Site Code:</b>	JES1
<b>West End Waypoint:</b>	515132 E, 6012698 N 12U	<b>Inventory Date:</b>	June 22, 2021

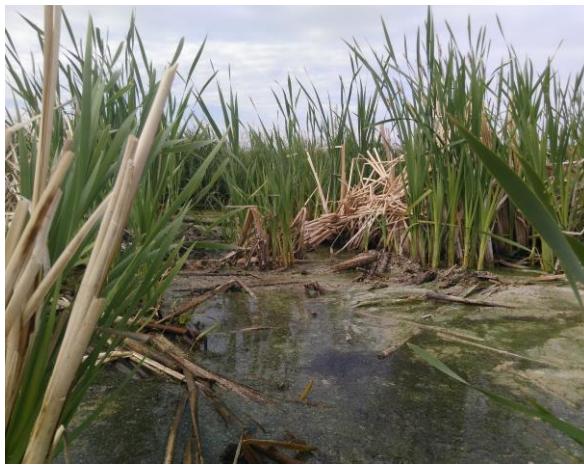
L. Givogue Stevenson, RHP01JES004

**JES1EBI.** East end, south view. There is an excellent vegetation buffer along water's edge, consisting primarily of cattails and native sedges. This provides important habitat for wildlife while protecting the shoreline from erosion.

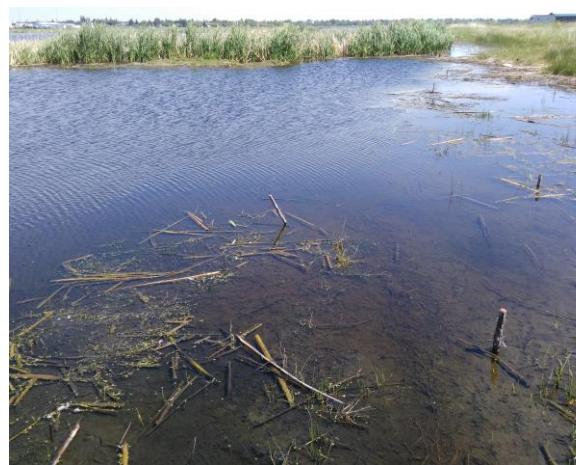
L. Givogue Stevenson, RHP01JES010

**JES1WBI.** West end, north view. High water levels over the last few years have encroached on the shoreline at this end of the site. Cattails are growing closer to shore in response to this higher water.

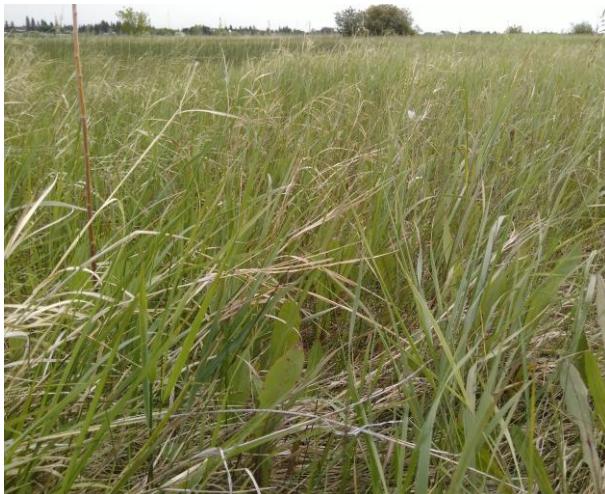
L. Givogue Stevenson, RHP01JES013

**JES1 A.** Young willow plantings (left) appear to have a relatively high success rate of survival within the site. The addition of woody vegetation will help in stabilizing the riparian zone and filtering nutrients.

- **Monitor young plantings.** Woody plants are the most vulnerable when they are young. Keep an eye out for them. As this area may see many recreators, providing signage or other notices to protect these vulnerable young plantings could prove helpful.

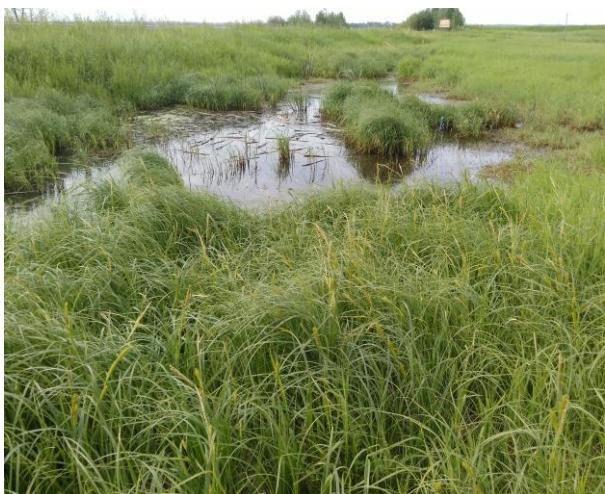
L. Givogue Stevenson, RHP01JES012

**JES1 B.** Some areas away from the shoreline are wet and marshy, which could possibly be influenced by the higher water table. Lots of dense sedges in the area are providing great habitat. These wet, open areas were present parallel to the shoreline, only occurring in parts of the site.

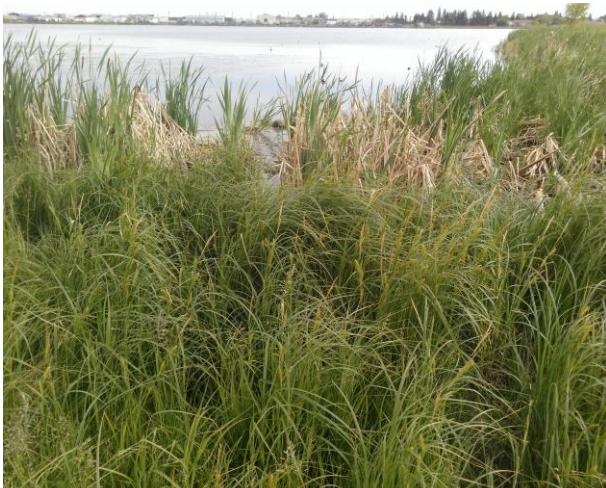
L. Givogue Stevenson, RHP01JES11

**JES1 C.** Emergent vegetation, with native sedges along the shoreline and cattails farther into the water, provides excellent habitat, and many birds were observed within this riparian site.

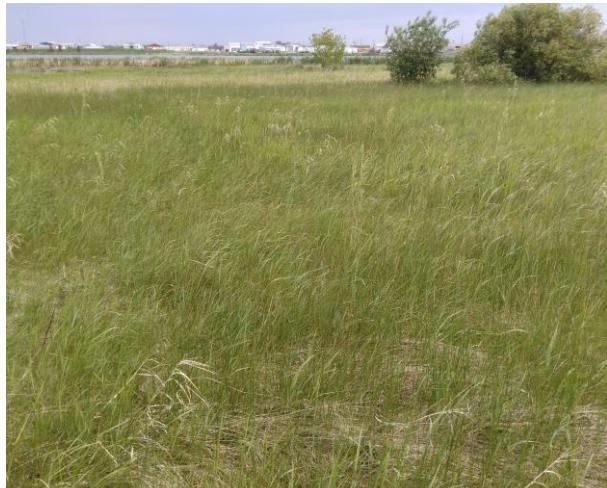
L. Givogue Stevenson, RHP01JES15

**JES1 D.** Non-native grasses such as Kentucky bluegrass and smooth brome dominated this site farther from shore. A few mature willows are present, while many willow plantings are beginning to establish (tall wispy vegetation visible in the foreground).

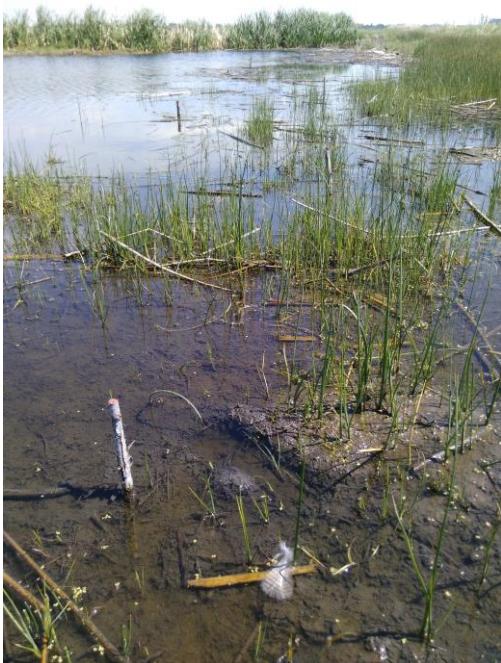
L. Givogue Stevenson, RHP01JES17

**JES1 E.** Some of the willow stakes that were planted along the shoreline are now inundated with water, and seem not to have survived. Many of the plantings farther away from the shoreline have good survival.
