# Cows and Fish

## Riparian Health Summary Report 2021

Jessie Lake

This summary report provides information on the current health of **Jessie Lake in SW 8-61-5 W4M** based on data we collected on **June 22, 2021**. This information is intended to help direct your efforts to promote important riparian functions such as improved water quality, forage production, and wildlife habitat.

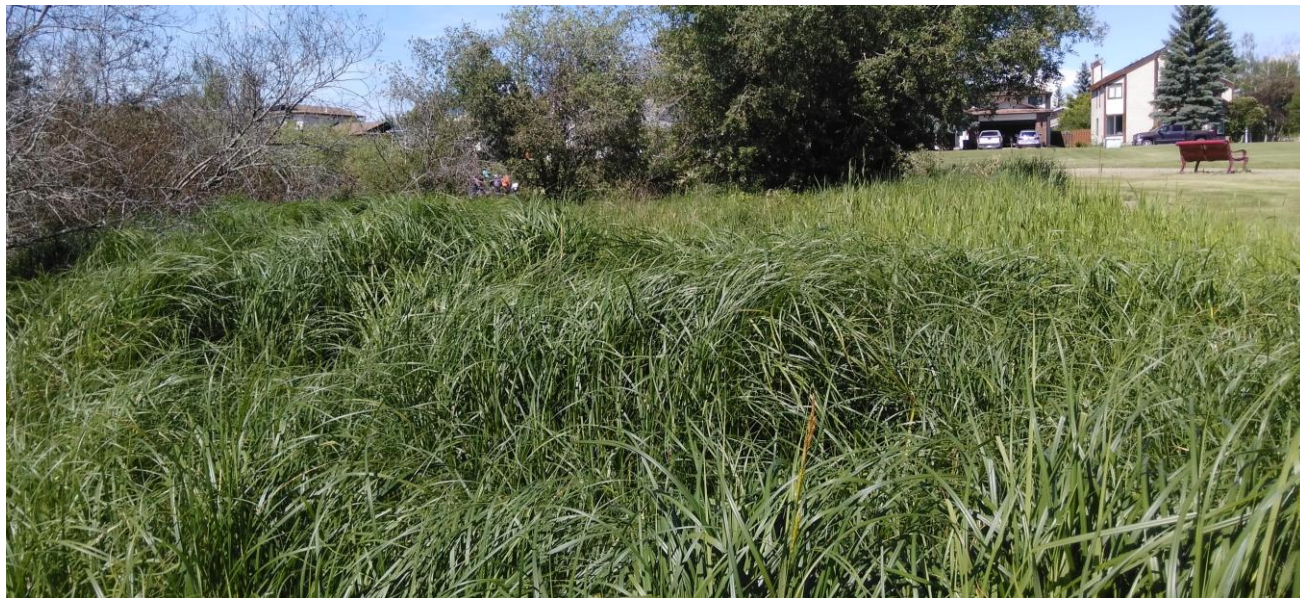
T. Dupuis, RHIP02JES003

This riparian area encompasses a recreational park area with a paved walking and biking trail along the lakeshore of Jessie Lake along with a manicured lawn, and ornamental trees and shrubs. Dense native vegetation is found in some areas closer to the water's edge. In 2019 and 2020, with the help of LICA, native shrubs (willows and red-osier dogwood) were planted (rooted-stock and live-staked) within the riparian area to increase woody plant cover and improve site stability. At the time of the site visit water levels were much higher than in past years, flooding out some of the paths.

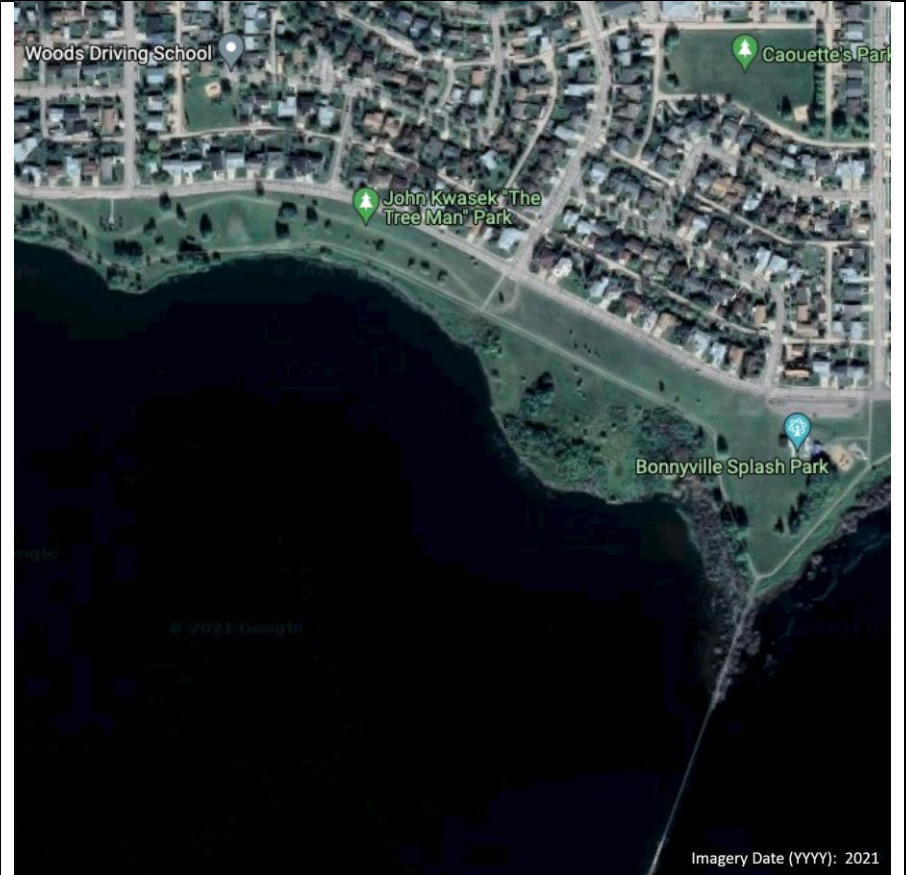
**Air Photo Date: Circa 2021**

**More current air imagery from Google Earth showing the recent flooding in the area. (See air photo on the left for site boundaries)**

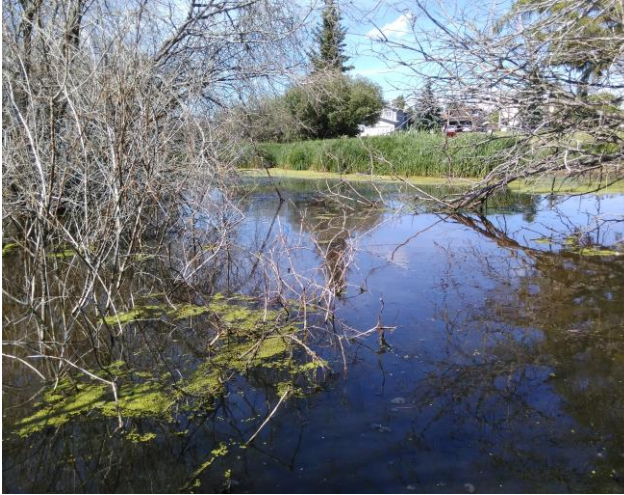
T. Dupuis, RHIP02JES003

**JES2EBI.** Southeast end, north view. Some mature willows in foreground have been drowned out due to increased water levels in recent years. In the background, there is excellent native vegetation, protecting the shoreline at this location.

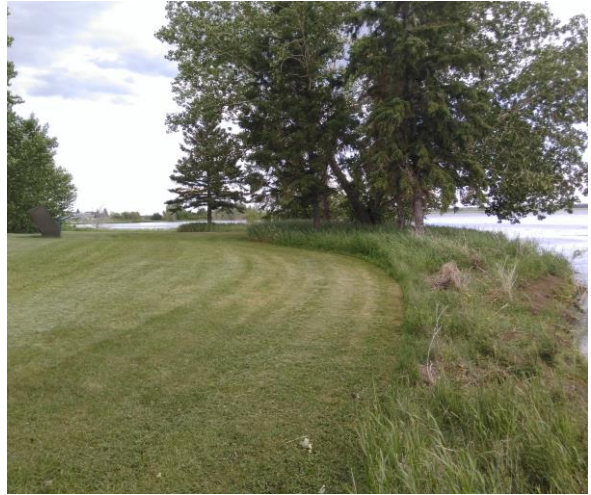
T. Dupuis, RHIP02JES015

**JES1WBI.** Southwest end, east view. Mowing occurs to close to the water's edge along the western parts of the assessed riparian area.

- **Promote natural recovery of your shoreline – give it a rest!** An easy way to improve the health of your lakeshore is to create a riparian buffer strip by leaving an un-mowed, undisturbed area near the water's edge. By simply leaving some grass uncut, desirable native plants can begin to re-establish in disturbed areas. Nature can be resilient if you give it a chance to make a comeback.

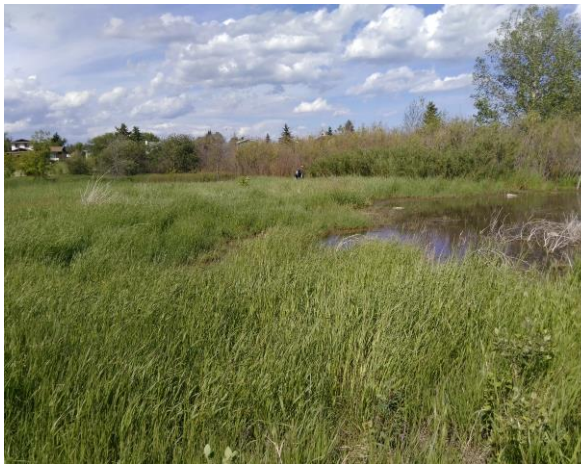
T. Dupuis, RHIP02JES022

**JES2 A.** A variety of native grasses, forbs, trees, and shrubs provide vegetative cover to the shoreline within the east part of the riparian area. This helps trap sediment and stabilize the shores.

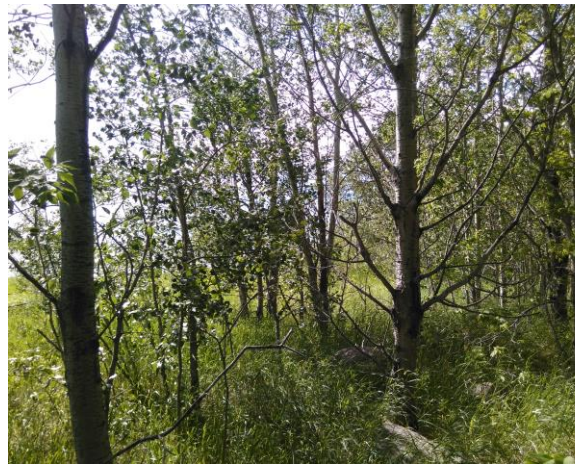
T. Dupuis, RHIP02JES024

**JES2 B.** Native aspen, where present, are displaying good age class structure with both young and mature trees present. Overall, this site could benefit from more cover of young preferred woody species like aspen and willows. It is important to have young trees to take over when mature trees and shrubs die off.

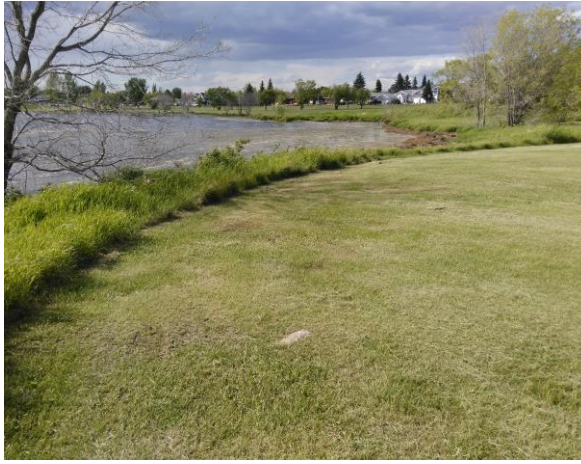
T. Dupuis, RHIP02JES025

**JES2 C.** In some locations, mowing is occurring within 1 meter of the water's edge. Leaving a larger natural buffer will allow native plants to establish and enhance riparian function.

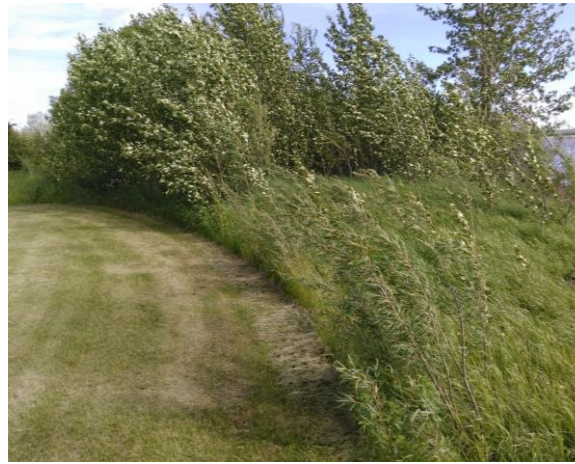
T. Dupuis, RHIP02JES026

**JES2 D.** In this location where mowing does not occur to the water's edge, a small vegetation buffer has been allowed to thrive. Young willows are beginning to establish, and the vegetation overall is taller than the mowed area, which will trap more sediment and nutrients as water travels overland to the lake. The deep-binding roots of the willows and other native woody vegetation in this buffer will help protect the bank from wave action and other erosion.

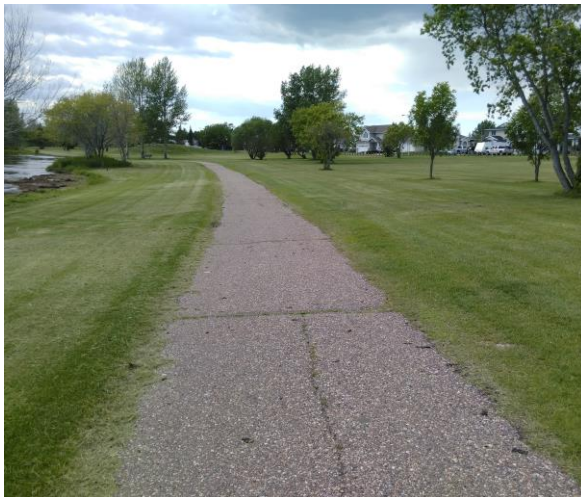
T. Dupuis, RHIP02JES027

**JES2 E.** A paved recreation pathway, along with surrounding mowed lawn, leads to most of this riparian area being highly compacted. Compaction can decrease water infiltration, increase overland flow, and limit vegetation from establishing.

- **“Soften” your shoreline and minimize creation of additional hardened surfaces.** Paved surfaces in the riparian area limit the moisture holding capacity of the floodplain and increase overland run-off of snowmelt and rainfall. Unfiltered runoff from paved surfaces is a contributor to degraded lake water quality. You can ‘soften’ your shoreline by letting natural debris wash ashore and by planting native plants in and around hardened structures.

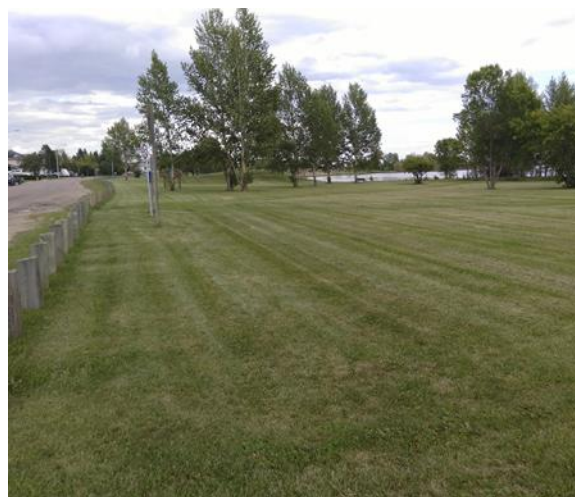
T. Dupuis, RHIP02JES020

**JES2 F.** The back edge of this riparian area is located along a road. Much of the area consists of a manicured lawn with mature horticultural and native trees in background.
