2023 CreekWatch Water Quality Monitoring Results

Buffalo Lake Métis Settlement

LICA Citizen Science

03/21/2024

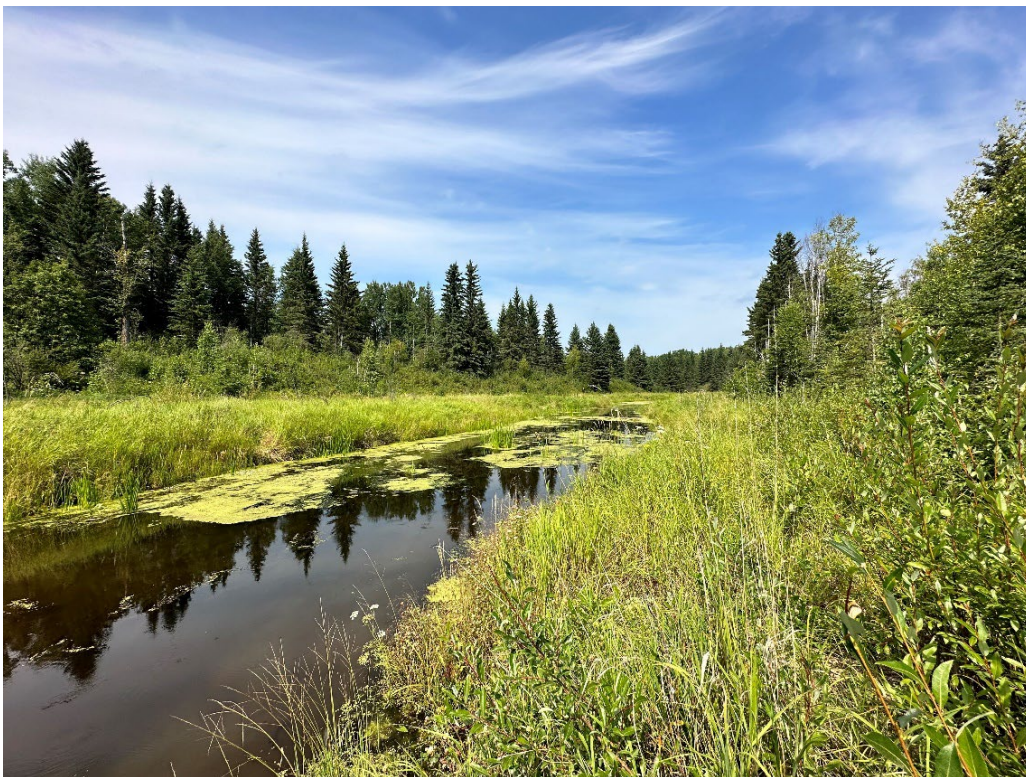
Figure 2. Sample site 2, facing downstream.

Site 2 (54.543859, -112.469403) is located on the north side of Buffalo Lake Métis Settlement, upstream of site 1. This is the outflow of Buffalo Lake, flowing north to connect with another tributary, before reaching the location of site 1. Sample site 2 was located at a bridge that is regularly used by vehicles and had evidence of recreational angling activity. This portion of the Amisk River system is surrounded in natural land with infrastructure (roads) and residences. Similarly with site 1, as this site too, is located along a portion of the Amisk River system, the results of riparian health assessments completed by Fiera Biological Consulting (2021), found this creek to have high riparian intactness and be of high conservation priority.

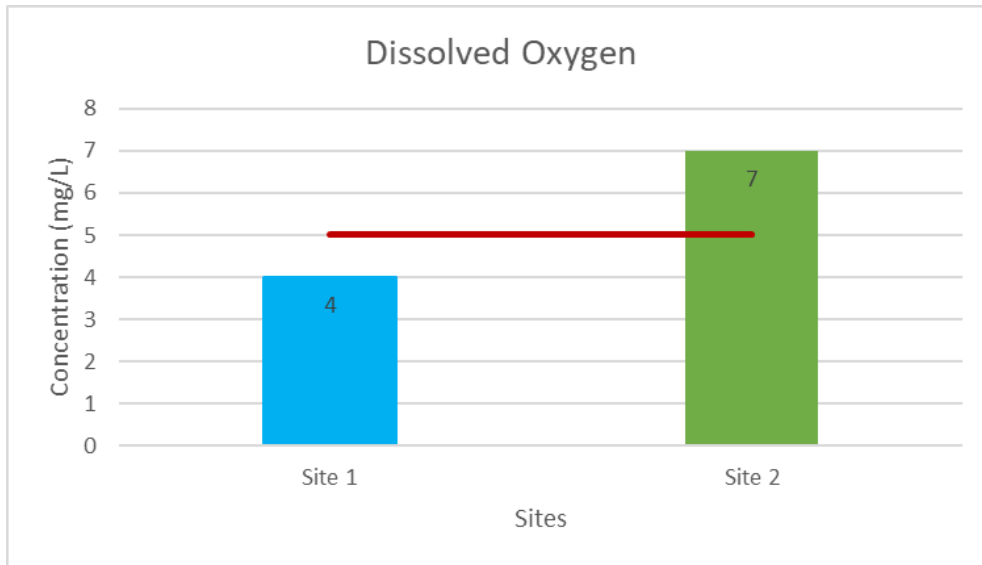
Figure 4. Dissolved Oxygen concentrations measured at the sample sites on August 2, 2023.

Dissolved Oxygen (DO) concentrations were measured using a Hach Kit with a drop-by-drop titration to show a change in water colour until totally clear. The red line in the graph below indicates the Environmental Quality Guidelines for Alberta Surface Waters (2018) for exceedance is minimum 5 mg/L for instantaneous value as the short-term allowance for the protection of freshwater aquatic life.

DO was found to be higher at Site 2 in comparison to Site 1, being 4 mg/L and 7 mg/L, respectively. Sample site 1 results indicate that DO levels are below the allowable limit to support freshwater aquatic life.

At the time of sampling, a small-bodied fish, invertebrates, and a Crayfish were observed at Site 1. Further monitoring is recommended to determine if DO levels collected during this sample event reflect actual in-stream conditions.

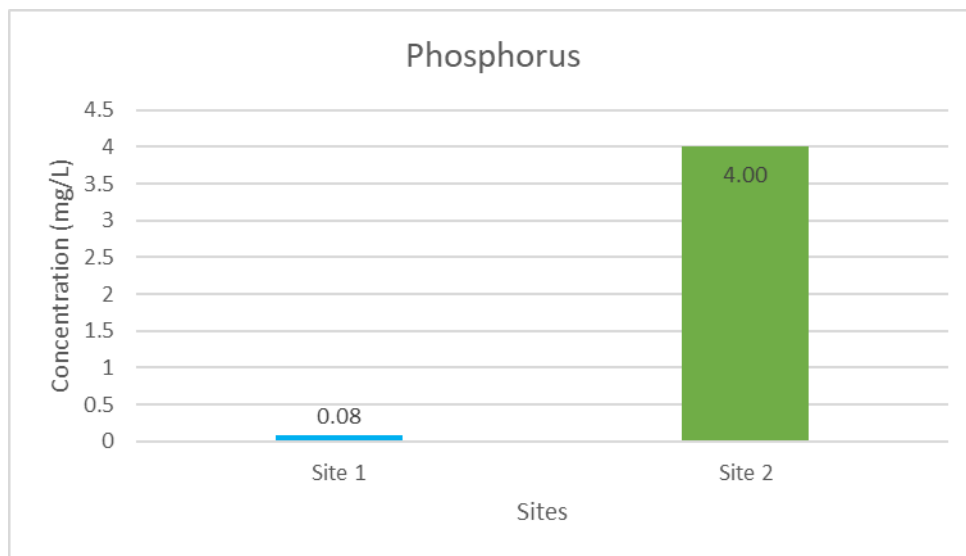
Figure 6. Phosphorous concentrations measured at the sample sites on August 2, 2023.

Phosphorus concentrations are measured using a Hach kit that compare a change in water colour.

The Phosphorous concentrations at site 1 were much lower than site 2. Results indicate that 0.08 mg/L and 4 mg/L of phosphorous were measured at site 1 and site 2, respectively. See Figure 6 for comparative results.

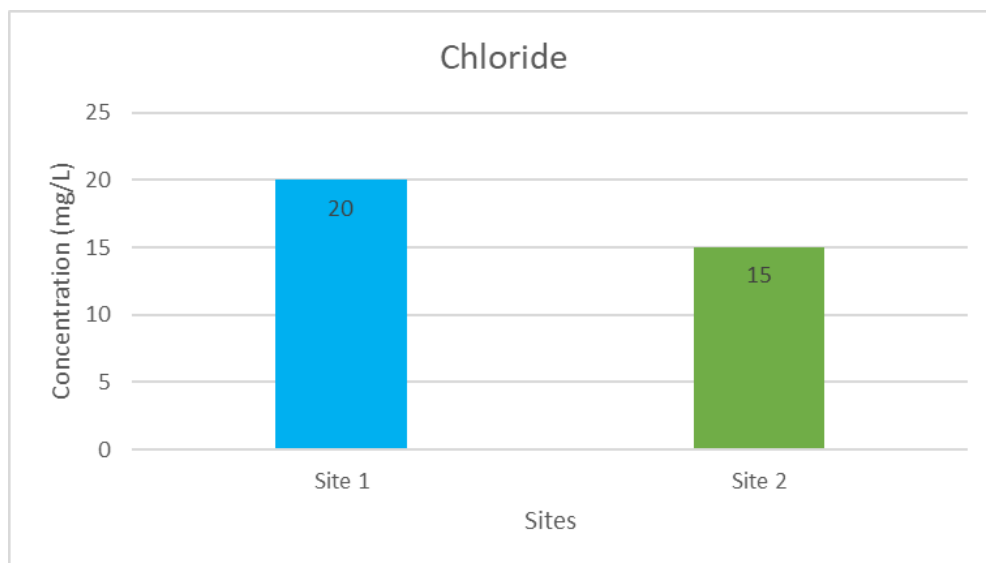
Figure 8. Chloride concentrations measured at the sample sites on August 2, 2023.

Chloride concentrations were measured using Hach Kits with a drop-by-drop titration to show a change in water colour from yellow to orange. The Environmental Quality Guidelines for Alberta Surface Waters (2018) is a maximum concentration of 120 mg/L.

Site 1 presented a greater concentration in comparison to Site 2, with results being 20 mg/L and 15 mg/L, respectively. Data collected at both sites fall within the allowable guideline limits. See Figure 8 for comparative results.
